SKYLINE INSPECTION SERVICES

Oakland, California
September 12, 2022 - 9:00 a.m.
Report Number 22204

Inspected by Bob Dillum
Member: American Society of Home Inspectors (ASHI)

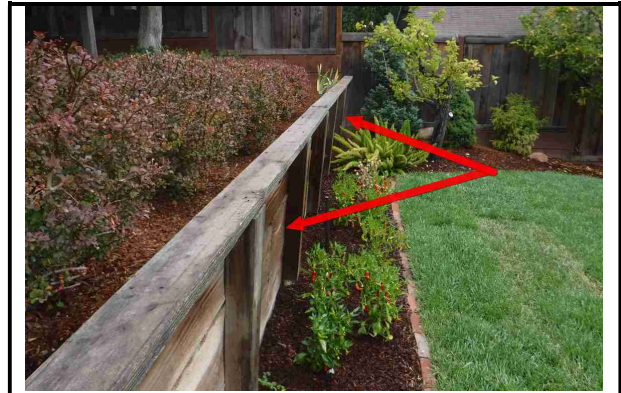
The left rear wood retaining wall shows displacement or leaning in several places and may soon need replacement.^{X8} We recommend periodic monitoring and repair by a qualified contractor if necessary.

Displaced rear retaining wall.

We recommend the retaining walls be checked periodically for future movement. Replacement may eventually be needed.

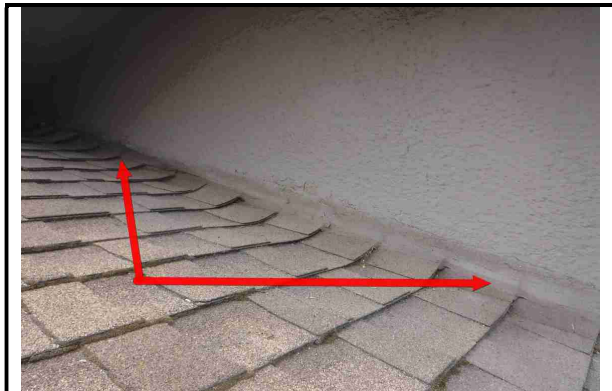
The roof-to-chimney connections are not properly flashed.

Improper roof-to-wall flashing.

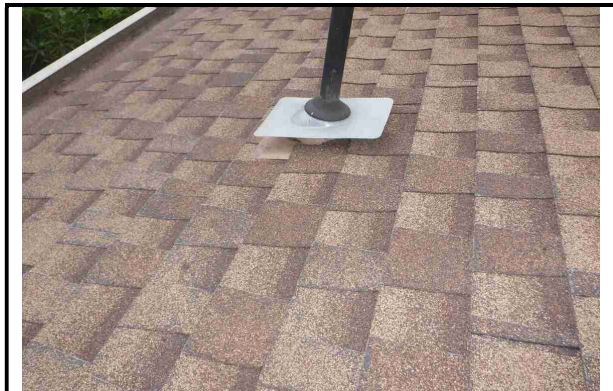
The roof flashings primarily are sheet metal.^{R2} Several of the roof flashings are not properly installed, which may result in roof leakage.

Improperly installed flashing.

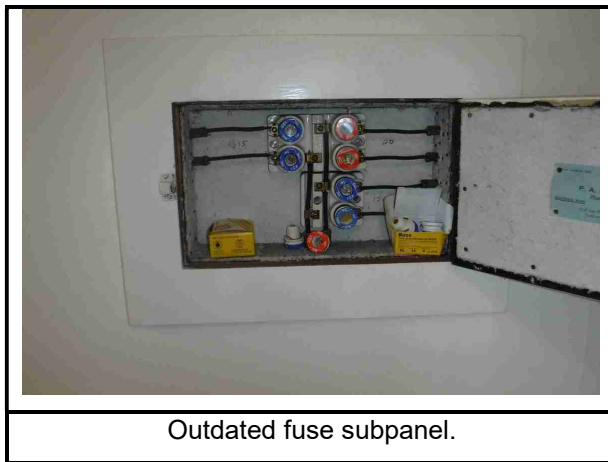
The neutral wires in this panel are protected by fuses in a “fused neutral” configuration, which is potentially hazardous.^{E1}

We recommend this panel be replaced with a modern circuit breaker panel.

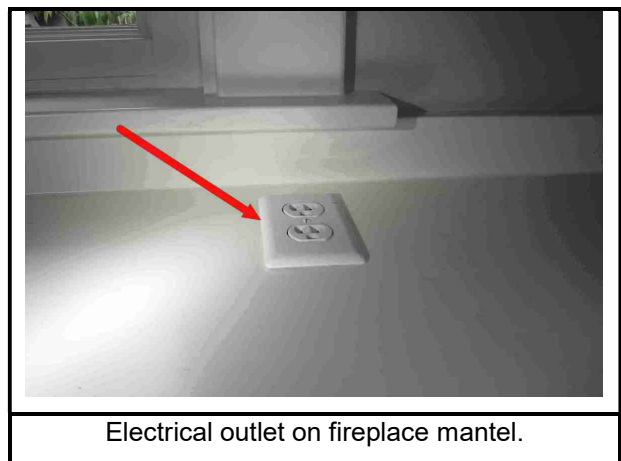
An electrical receptacle has been installed on the fireplace mantel, with the openings facing upward, which would allow spilled fluids to flow into the outlet, causing damage or creating a potentially hazardous condition. We recommend it be removed or relocated to a vertical surface where water and other liquid spillage is less likely.

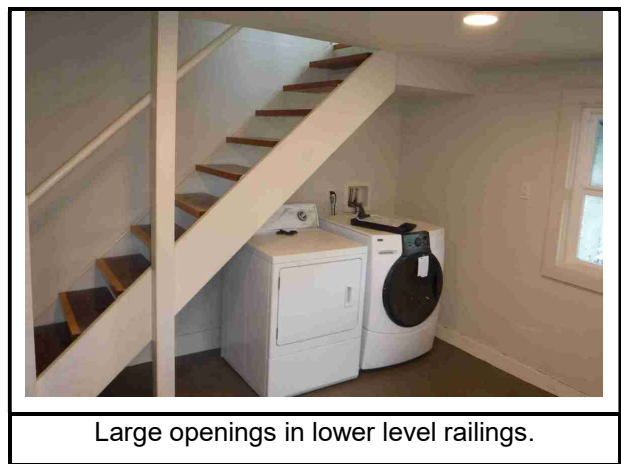
There are large openings in the lower level stair railings, creating a potentially unsafe condition.¹⁵ The stair railing to the lower level does not terminate against the wall or a post as required in new construction and can catch clothing, creating a falling hazard.

We recommend proper railings be installed as needed for safety.

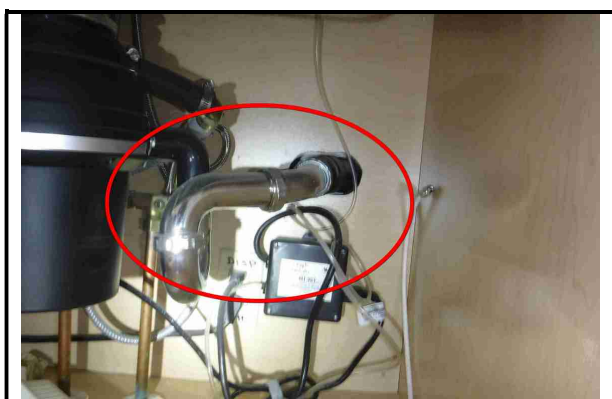
Negative slope at kitchen sink drain.

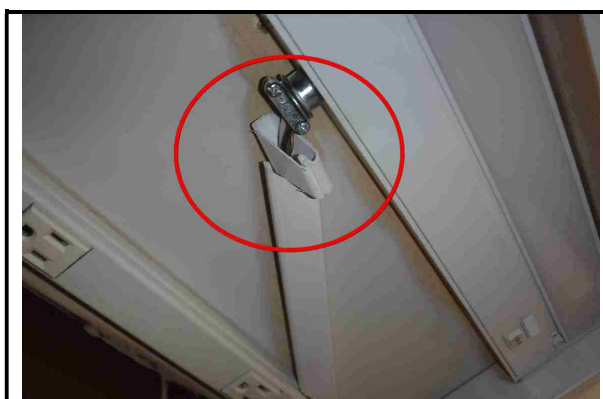
Exposed wires under an upper kitchen cabinet.
