SKYLINE INSPECTION SERVICES

Walnut Creek, California December 20, 2022 - 9:00 a.m. Report Number 22234C

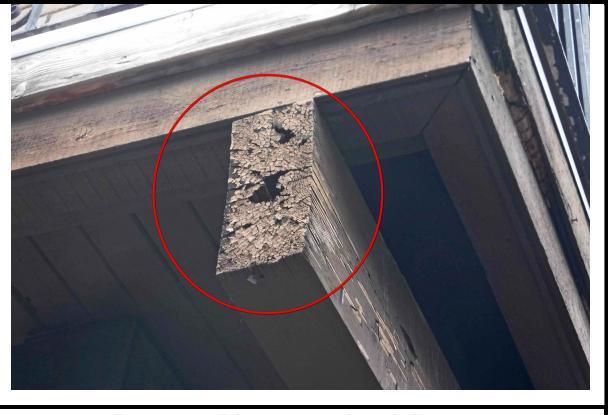
The exposed beam at the right rear is damaged from weather exposure. We recommend the damaged beams be repaired or replaced as needed.

Damaged beam at the right rear

2. The exposed beam at the right rear is damaged from weather exposure. We recommend the damaged beams be repaired or replaced as needed.

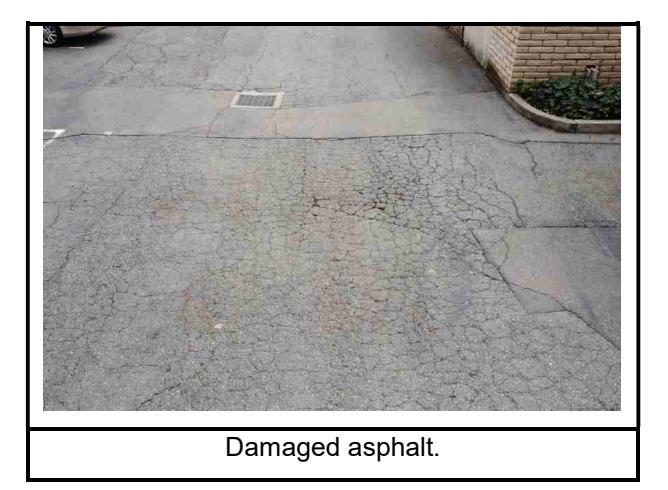
There is an asphalt-surfaced driveway and parking area at the front and left side of the building. There are approximately 13,250 square feet of paved driveway and parking area. The asphalt-surfaced driveways and parking areas are in very worn condition and we observed damage in several locations. The asphalt has been patched in several locations. We recommend the driveways and parking areas be examined, repaired, and resealed by a qualified contractor. The need for replacement of the asphalt surfaces should be anticipated.

We counted approximately 112 total parking

spaces. There are two parking spaces at the front designated for handicap use. The painted parking striping is worn and we recommend it be repainted.

3. We recommend the driveways and parking areas be examined, repaired, and resealed by a qualified contractor.

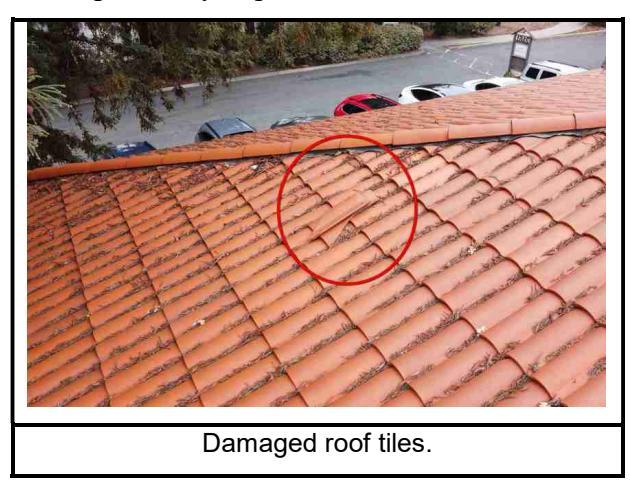
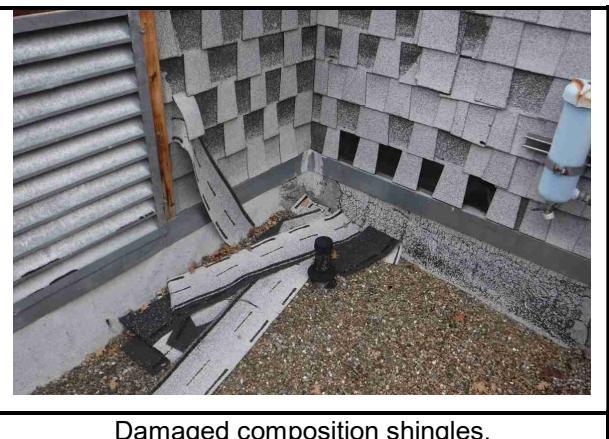
There is composition shingle roofing on the vertical surfaces on the center mechanical equipment roof. Many shingles are damaged or missing. This roofing is in poor condition and we recommend it be replaced by a qualified roofer.

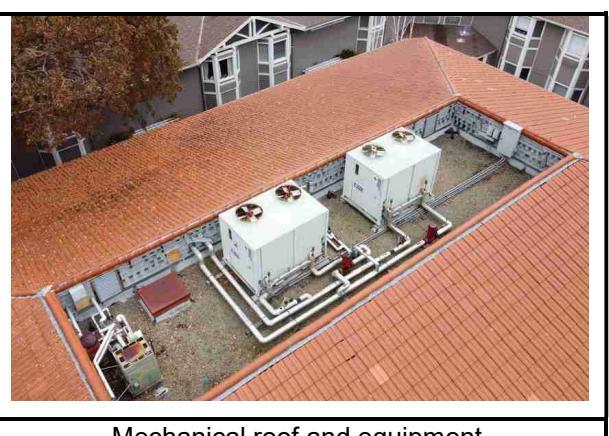
Mechanical roof and equipment.

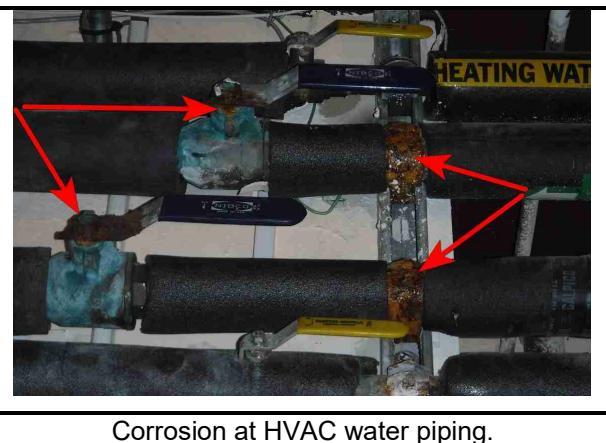
There are several direct connections between the copper pipes and galvanized piping supports causing corrosion at several fittings. A direct connection between these two has caused rust or corrosion in several fittings. We recommend proper, noncorrosive fittings be installed as needed to properly separate galvanized and copper piping.

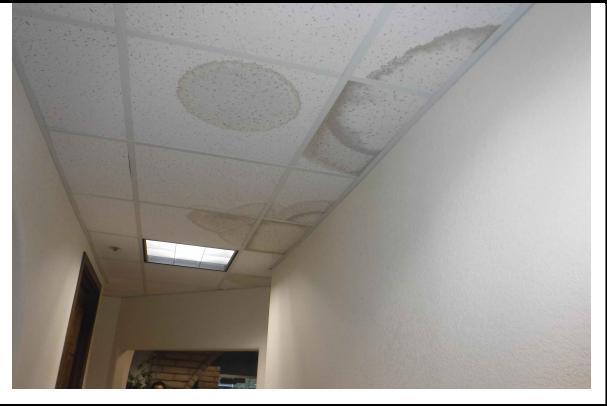
with the exception of space 107, have acoustic tile in suspended metal-framed T-bar ceilings. Several of the ceiling tiles are stained indicating prior leakage We recommend periodic monitoring and repair by a qualified contractor if necessary.

Stained ceiling tiles in the common area

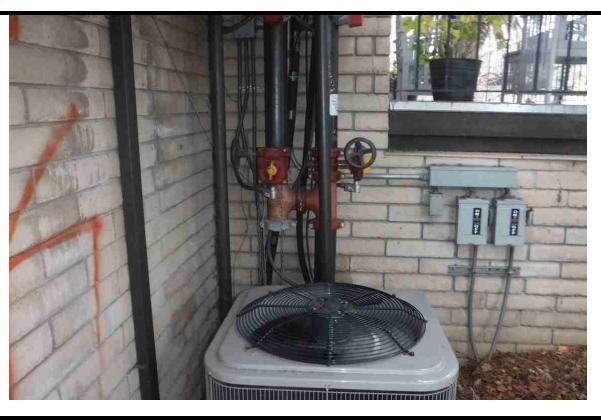
Fire sprinkler controls.
